Imaging Artifacts of Medical Instruments in Ultrasound-Guided Interventions

Objective. Real-time 3-dimensional (3D) ultrasound imaging has the potential to become a dominant imaging technique for minimally invasive surgery. One barrier to its widespread use is that surgical instruments generate imaging artifacts, which can obfuscate their location, orientation, and geometry and obscure nearby tissue. The purpose of this study was to identify and describe the types of artifacts which could be produced by metallic instruments during interventions guided by 3D ultrasound imaging. **Methods.** Three imaging studies were performed. First, imaging artifacts from stainless steel rods were identified in vitro and acoustically characterized. Second, 3 typical minimally invasive instruments were imaged (in vitro and in vivo), and their artifacts were analyzed. The third study compared the intensity of imaging artifacts (in vitro and in vivo) from stainless steel rods with rods composed of 3 different materials and stainless steel rods with roughened and coated surfaces. **Results.** For the stainless steel rods, all observed artifacts are described and illustrated, and their physical origin

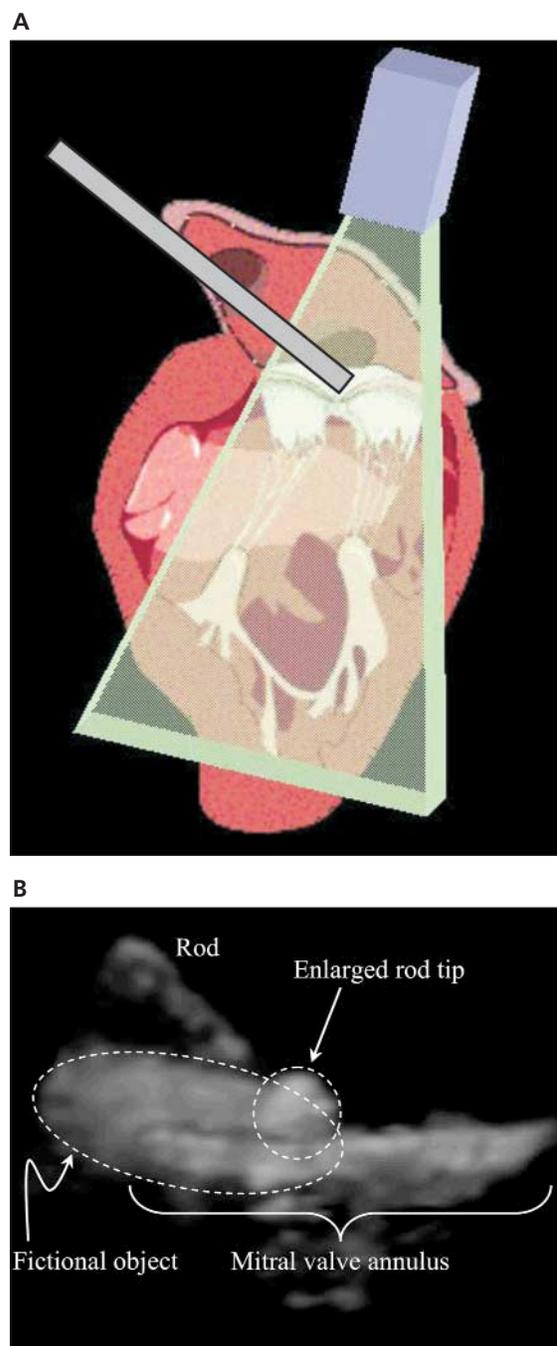
Figure 1. Three-dimensional ultrasound image of a rod inserted into an in vitro pulsatile model of the porcine mitral valve. **A**, Schematic indicating relative probe and rod locations relative to actual anatomy. **B**, Image of in vitro model depicted from the reader's viewpoint of **A** showing artifacts.

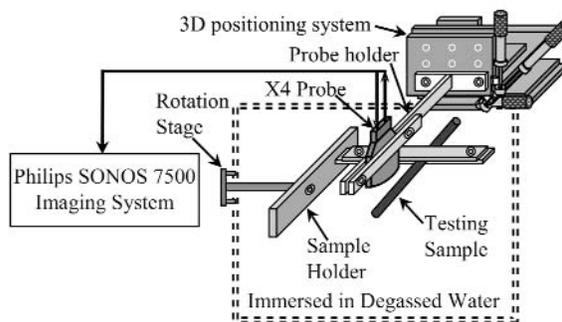
Figure 2. Schematic of the imaging apparatus.

In vitro experiments were carried out in a tank (Figure 2) that has been described in detail previously.⁵⁶ Briefly, the tank was filled with filtered, deionized, degassed water, and the bottom was lined with silicone rubber to reduce reverberations. The rod or instrument to be visualized was mounted to a rotational stage so that the angle of insonation could be varied. The X4 probe was mounted to a 3-axis positioning system and was initially translated to ensure that the instrument was placed in the focal plane. The desired orientation of the rod relative to the probe was then obtained by adjusting the rotation stage. The focal length and the imaging depth could be varied as desired. A 2D image was then acquired and saved as a TIFF (tagged image file format) image file. The corresponding 3D images were then acquired and saved as DICOM (Digital Imaging and Communications in Medicine) files. In post analysis, the DICOM files were imported, and 3D volumes could then be viewed from any angle. Once a desired viewing orientation was obtained, an AVI (audio-video interleave) movie file was saved to disk. A desired frame of the movie file was saved as a TIFF image.

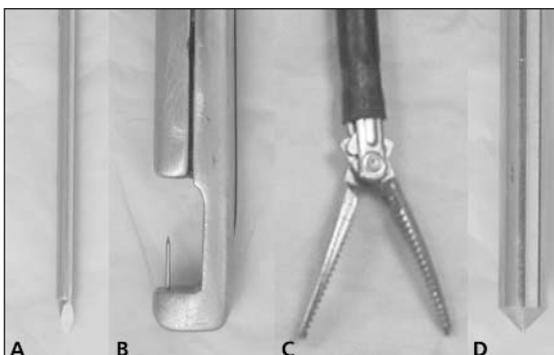
Figure 3. Clinical tool examples. **A**, 19-gauge needle. **B**, Suturing device. **C**, Forceps. **D**, Stainless steel rod with conical tip.

Cylinders serve as a convenient geometry for characterizing instrument artifacts because they are accurate representations of an instrument's shaft, and furthermore, many tip-mounted tools can be approximately modeled as a collection of cylinders. Stainless steel (type 304) rods (Figure 3D) were used in the first study as canonical objects with which to identify and characterize instrument imaging artifacts.

The 3 minimally invasive instruments used in the second study are also depicted in Figure 3. Cylindrical needles (Figure 3A) are the most commonly used tools in ultrasound-guided interventions (eg, needle biopsies, drug delivery, and hyperthermia therapy). Figure 3B shows a suturing device consisting of 2 semicylinders, which slide relative to each other along the instrument's axis (developed by Y. Suematsu and

Mani Inc, Tochigi, Japan). There is a concave slot on the tip of the device for the needle. A forceps (Figure 3C) consists of a hollow cylindrical shaft containing a cable to control finger position. The 2 fingers of the forceps are tapered semicylinders with ridged grasping surfaces. These descriptions validate the statement above that instruments can often be modeled as collections of cylinders.

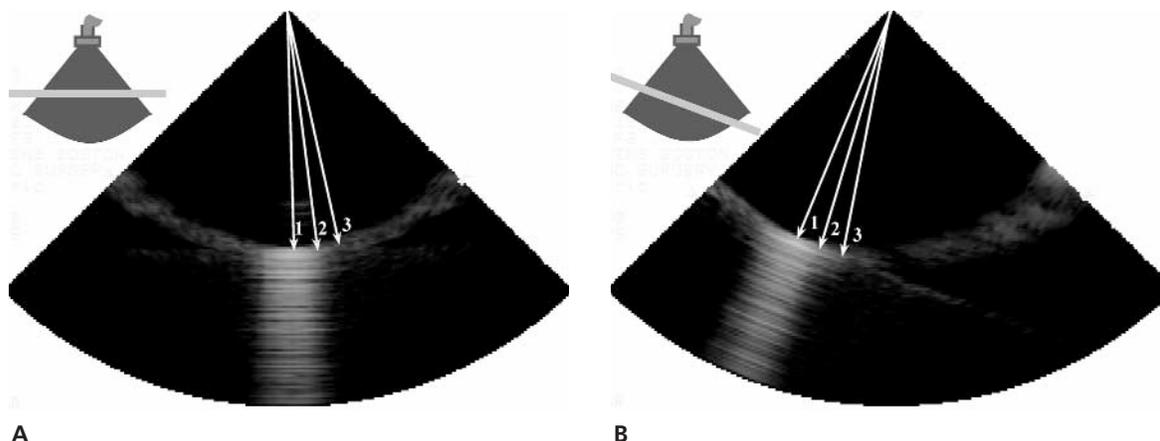
A **B**
Figure 4. Images of a 3.2-mm-diameter stainless steel rod showing comet tail artifacts. **A**, Horizontal rod. **B**, Rod oriented at 20°. Both rods are in the scan plane.

Comet Tail Artifact—The comet tail artifact is shown for a rod in Figure 4. The bandlike structure is strongest when the rod is exactly perpendicular to the beam (Figure 4, beam 1). For a linear scan, the bandlike structure will be uniform along the length of the instrument. For a sector scan, as used here, the angle of incidence will vary across the length of the instrument because of the steering of the beam. As the angle of incidence departs from normal, the tail becomes weaker because the multiple reflections do not return directly to the transducer (Figure 4, beam 2) until the reflections are direct-

ed far enough away that they are not detected by the transducer (Figure 4, beam 3). Indeed, at this angle, the reflection from the surface is not present in the image. The curved hazy region is a side lobe artifact that will be discussed later. In the comet tail, the band structure is quite rich; that is, it does not appear to produce periodic banding. This appears to be because the ultrasound pulse couples into a number of modes in the rod so that each produces echoes back to the imaging transducer.

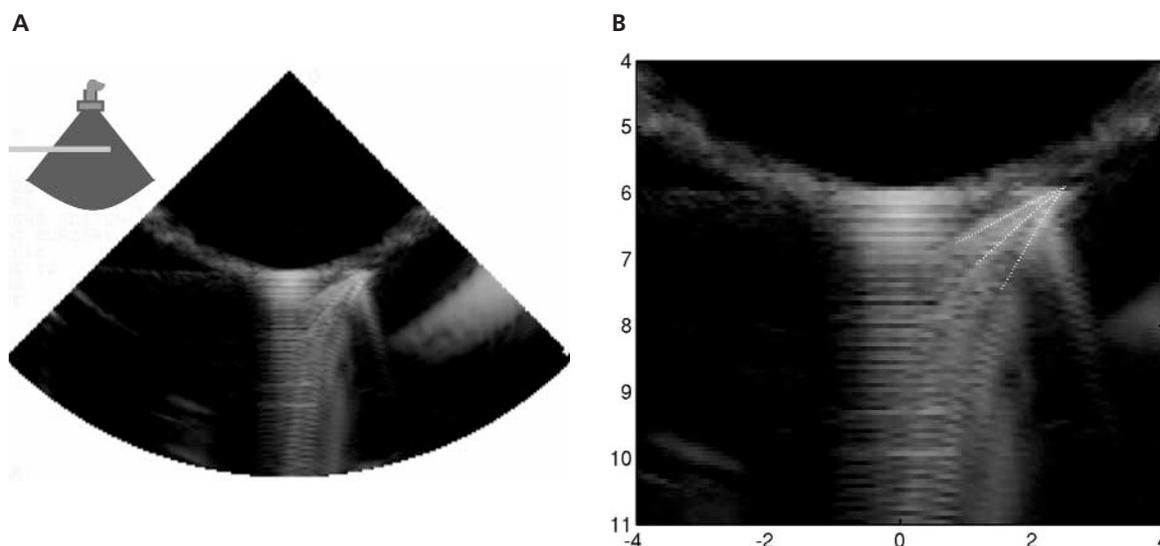
Figure 5. **A**, Image of the guided wave artifact with 3 fingers emanating from the tip. **B**, Magnified view of fingers with predicted guided wave echo locations for wave speeds of 4500, 3300, and 2300 m/s (top to bottom). Axis numbers indicate distance in centimeters.

Figure 5 shows an image of a horizontal rod where the tip is on the right side of the image. Although the comet tail artifact can be seen at normal incidence, the guided wave artifacts appear as 3 “fingers” emanating from the tip of the rod, which curve down and to the left.

where θ_T is the angle to the tip of the instrument. The presence of 3 fingers in Figure 5A indicates that 3 types of guided waves were excited by the ultrasound pulses. Each traveled along the rod,

was reflected, and resulted in an echo signal detected by the transducer. Figure 5B overlays on the image the echoes predicted by Equation 2 for 3 different guided wave speeds: 4500, 3300, and 2300 m/s. The curves provide a good match with the image and support the guided mode hypothesis. Note that these guided wave speeds are consistent with a large number of modes for the rod, and it was not possible to identify the precise modes from the data.

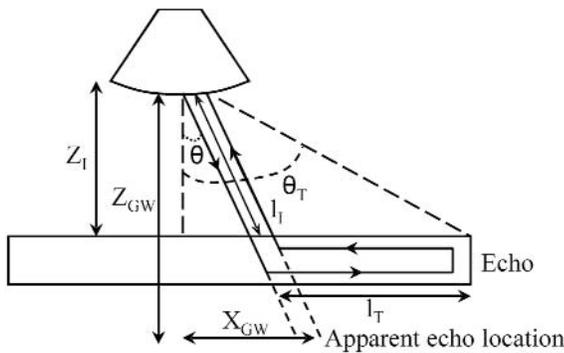
Figure 6. Schematic showing the geometry of the guided wave artifact. The solid lines with arrows show the actual propagation path of the waves. The dashed lines show the propagation path assumed by the imaging system.

This artifact is produced when the incident acoustic beam couples into modes that travel along the shaft of the rod. These modes reflect from the end of the rod, or any other discontinuity, such as a hinge, and propagate back to the transducer. Figure 6 demonstrates the acoustic path, which consists of a wave propagating to the instrument, the guided wave that propagates to

the end of the rod and back, and a wave that radiates back toward the transducer. The total travel time for the reflection of the guided wave from the tip of the instrument will be

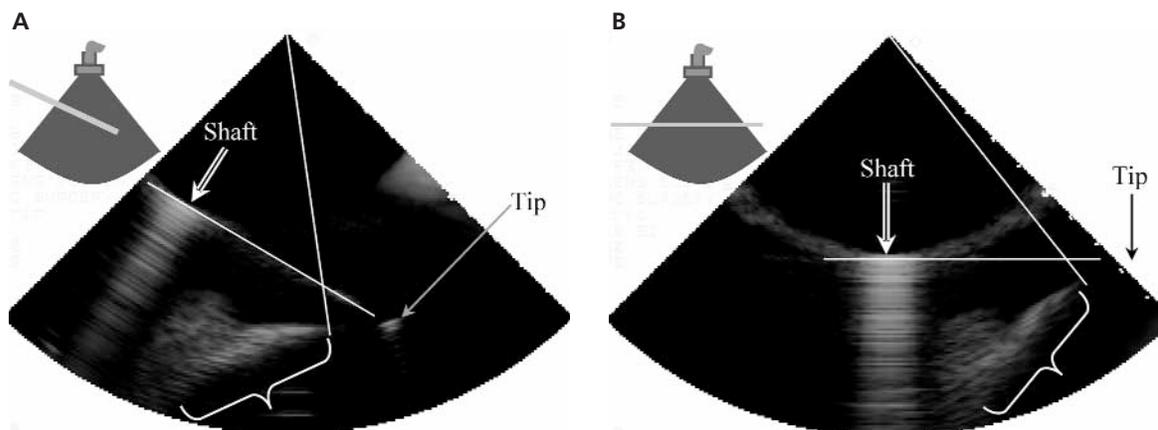
Figure 7. Images of a 3.2-mm-diameter stainless steel rod with a conical tip showing a guided wave reverberation artifact that has separated from the tip. The white lines show the surface of the shaft and the effective “ray” that delineates the edge of the artifact. The angle between the lines was used to determine the critical angle of the guided wave. The arrow denotes the actual location of the tip. **A**, The tip is in the field of view. **B**, The tip is out of the field of view, but the guided wave artifact is present in the image.

A guided wave can only be excited when the angle of incidence is less than the critical angle, $\theta_{CRIT} = \arcsin(c_0 / c_{GW})$. As a result, guided wave artifacts do not necessarily extend to the reflecting tip, as shown in Figure 5. Figure 7A depicts such a case. The guided wave artifact vanishes at an angle of 39.3°, corresponding to a guided wave speed of 2400 m/s. This is consistent with the slowest measured guided wave speed of 2300 m/s (and largest critical angle) shown in Figure 5. The artifact can even be present when the reflecting tip is outside the image (Figure 7B).

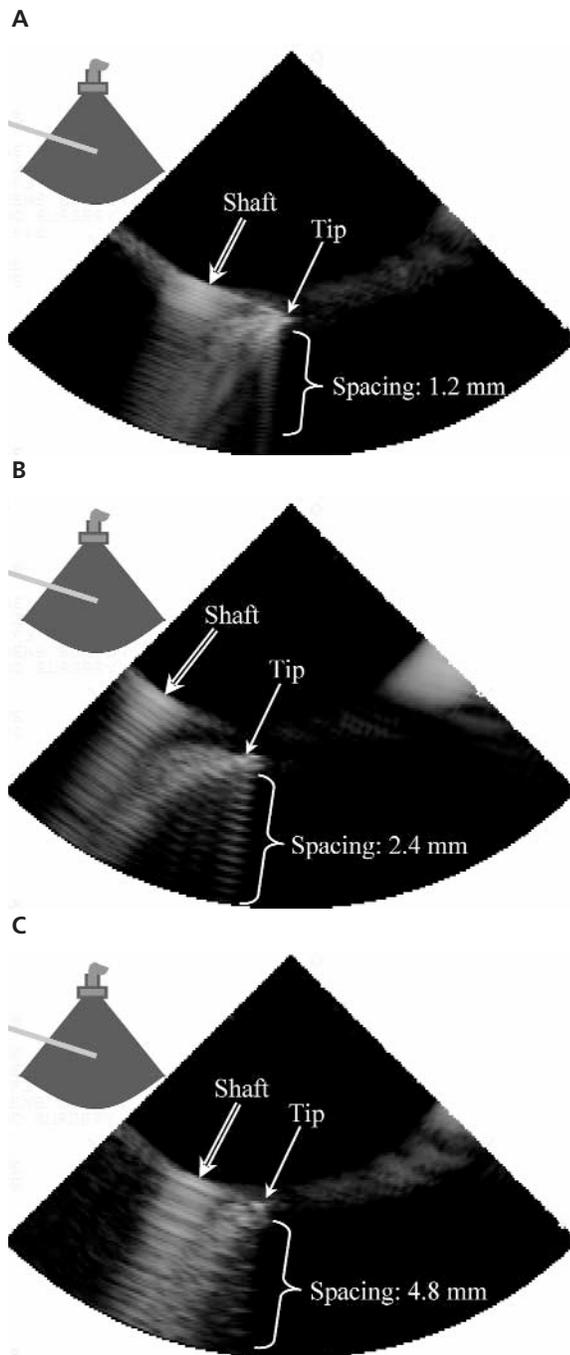
Figure 8. Effect of rod diameter on tip reverberation artifacts for conically tipped stainless steel rods. **A**, 1.6-mm-diameter rod. **B**, 3.2-mm-diameter rod. **C**, 6.4-mm-diameter rod.

Tip Reverberation Artifacts—The tips of cylindrical rods produce a particularly strong reverberation artifact. They appear to be conducive to efficient generation of a specific internal mode, which reverberates to produce a comet tail with periodic banding. This artifact is shown in Figure 8 for a cylindrical rod with a conical tip. We have found that a flat tip produces the same artifact, although the bands are not as strong and distinct. The banding always appears as a short line that is oriented perpendicular to the incident angle of the transducer. The first reflection is almost always very strong (even if the tail is not visible), and it appears that the geometry of the tip acts as an acoustic analogue of a retroreflector.

The periodicity of the banding is directly related to the diameter of the rod, as shown in Figure 8, in which the diameters of the rods (1.6, 3.2, and 6.4 mm) have the same ratio as the periodicity of the banding in the comet tail (1.2, 2.4, and 4.8 mm, respectively). The line spacing of the comet tail corresponds to echo intervals of 1.56, 3.12, and 6.24 microseconds, respectively. The periodicity of the bands implies that just a single mode is responsible for this artifact. For waves that travel straight through the rod, the effective wave speed to produce the measured banding

would need to be 2.1 mm/ μ s, much less than the compressional or shear wave speeds in the object, so this signal does not correspond to a simple reverberation model. For waves traveling around the surface of the instrument, the interval corresponds to a circumferential wave speed of 3.2 mm/ μ s. The speed of a Stonely surface or interface wave⁵⁸ for a stainless steel half-space loaded with water is 2.9 mm/s. The speed of a circumferential wave²⁰ should approach that of the shear wave speed of steel, 3.1 mm/ μ s. Therefore, the most likely candidate for this artifact is a circumferential wave.

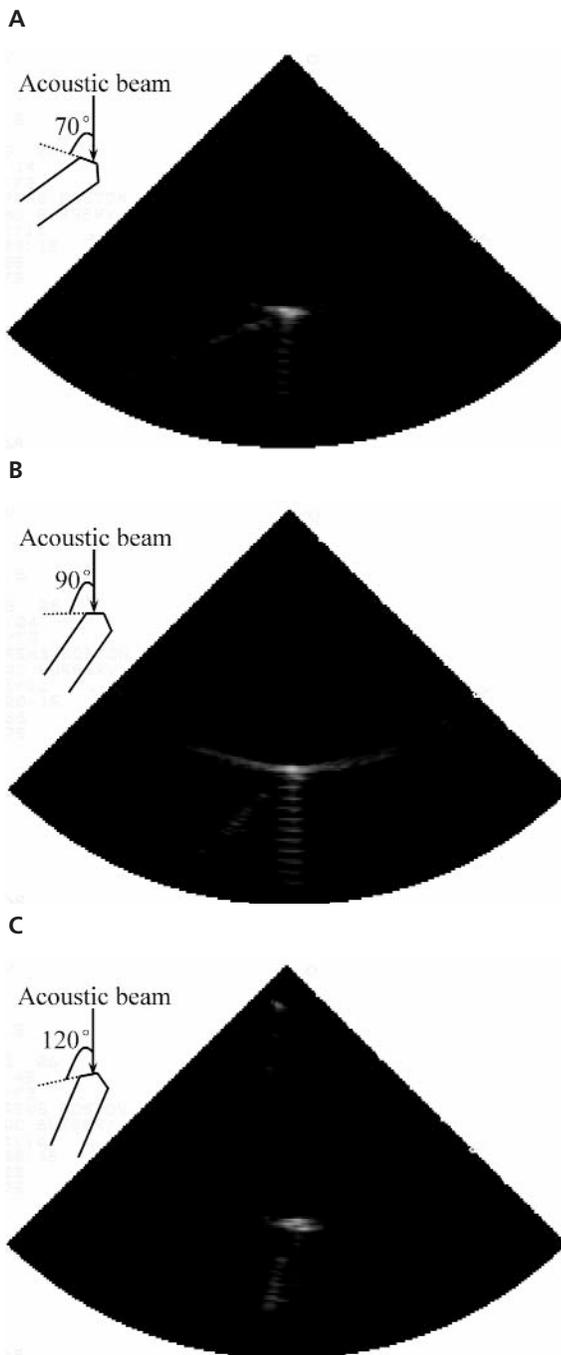
Figure 9. Tip reverberation artifact as a function of angle. The angles denoted are the angles between the top proximal surface and the acoustic beam, as shown in the top left corner. **A**, 70°. **B**, 90°. **C**, 120°.

The amplitude of the tip artifact is dependent on the geometry of the tip. Figure 9 shows the tip reverberation artifact at 3 different angles, α , between the proximal surface and the acoustic beam. The images show that, for the conical tip, the brightness of the tip artifact is strongest when the proximal surface is at an angle $\alpha \approx 20^\circ$ (as shown in Figure 8) and normal to the acoustic beam (Figure 9). It is observable, however, at almost all angles of incidence.

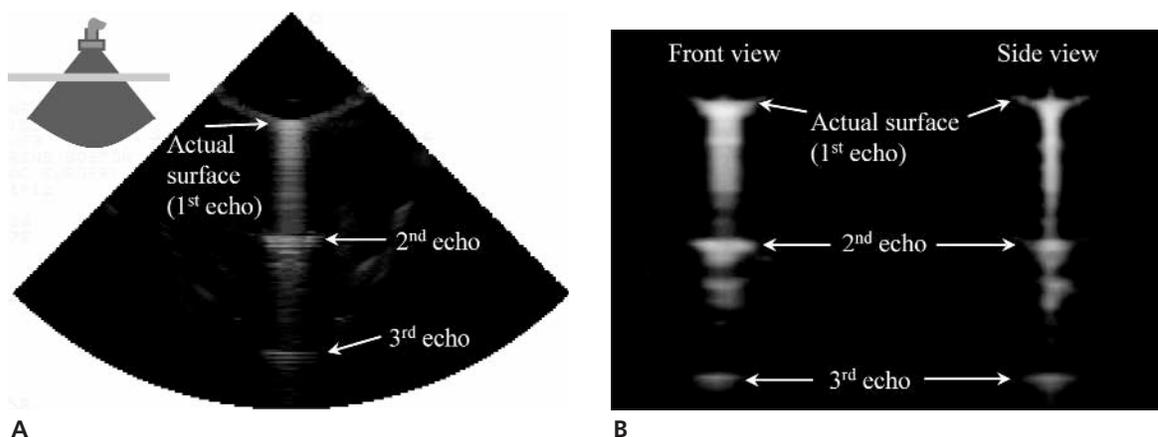
Figure 10. Probe-instrument reverberation artifacts for a 3.2-mm-diameter stainless steel rod. **A**, 2D image. **B**, 3D images.

Probe-Instrument Reverberation Artifacts—The reverberation artifacts described above are due to reflection within the instrument. Reverberation can also arise from reflections between the instrument and the probe. This will result in ghost images of the instrument at integer multiples of the true distance between the probe and instrument. Figure 10 shows an image of a cylindrical

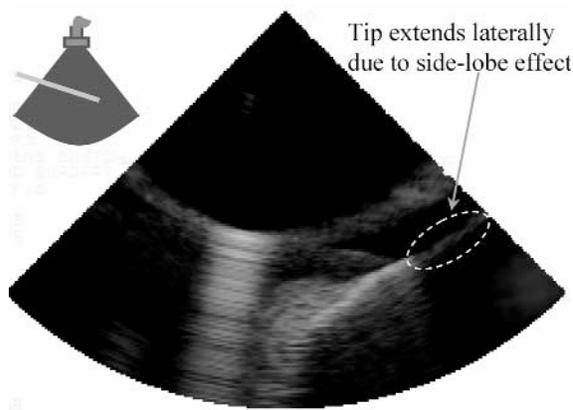
Figure 11. Diffractive side lobe artifact for a 3.2-mm-diameter stainless steel rod with a conical tip. The artifact appears as curvilinear segments emanating from the tip.

Diffractive Side Lobe Artifacts—Edges and corners of instruments with radii of curvature on the order of the acoustic wavelength will scatter incident waves over a broad range of angles. Even though the incident energy is redistributed in many directions, the impedance difference between the instrument and tissue is sufficient to produce detectable echoes over all these directions. Figure 11 shows the bright signal from the tip of a conical rod and the curved side lobe artifacts. The artifacts are curvilinear because even when the main lobe is directed away from the tip, the side lobe is incident on the tip and produces an echo. Because the travel time from the tip will

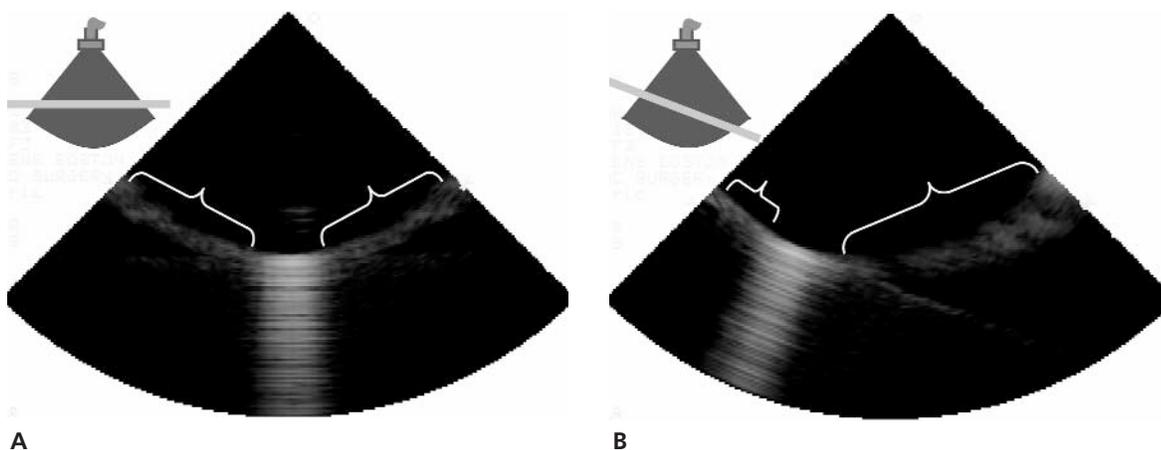
Figure 12. Specular side lobe artifacts of a 3.2-mm-diameter stainless steel rod. **A**, Horizontal rod. **B**, Rod oriented at 20°.

is oriented such that a side lobe is normally incident, then it will produce a strong echo signal, which will appear as an artifact. Figure 12 shows this for both a horizontal rod and a rod oriented at 20°.

For the horizontal rod in Figure 12A, the center of the sector scan sees a specular reflection and the comet tail artifact. At the edges of the image, the pulse from the main lobe is reflected away from the probe and does not return an echo. However, a side lobe signal will propagate directly down to the instrument and be reflected back to the scanner. As with the tip artifact, the timing of this echo will be such that it produces a curved artifact on the image. The artifact appears continuous because, as described in the introduction, the short-duration pulses used in imaging systems do not induce the interference patterns observed for a continuous wave source. Note that for this orientation the artifact should not be present for a linear probe because all the lines would be normally incident on the instrument. In Figure 12B, the same effect occurs for a rod at 20°. The specular reflection and comet tail artifact can be seen, and on either side, the curved side lobe artifact is present. In this orientation, a linear scan would also result in an artifact.

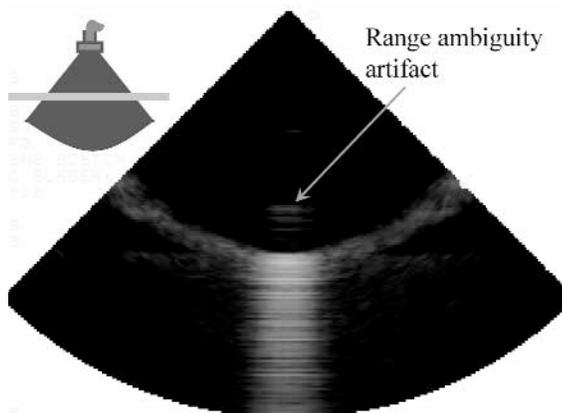
Figure 13. Range ambiguity artifact for a 3.2-mm-diameter stainless steel rod.

a high enough rate that distant echoes from a prior pulse are interpreted as responses to the most recent pulse, and the axial distance from the probe is assigned accordingly. When imaging instruments, this artifact is likely to occur in conjunction with reverberation artifacts. Two likely candidates are the comet tail artifact, which can be very long because of the low inherent absorption of steel, and reverberation between the probe and the instrument. Figure 13 shows an example of an artifactual surface between the probe and the rod. This effect is likely to be most pronounced when the imaging is carried out through a medium with low attenuation, over a short range, and with a high frame rate. It can be reduced or eliminated by decreasing the frame rate.

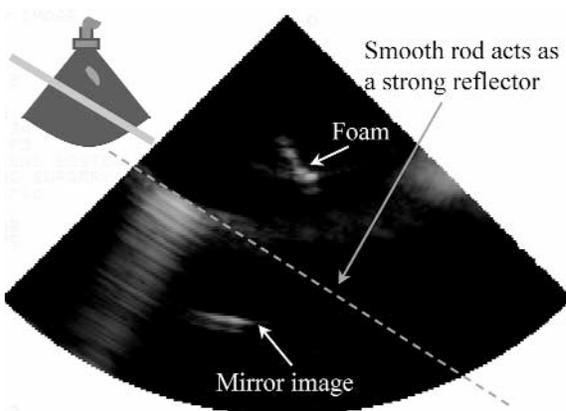
Figure 14. Mirror-image artifact produced by a 3.2-mm-diameter stainless steel rod with a piece of polyurethane foam.

Mirror Image Artifacts—When instrument surfaces act as specular reflectors, they can enable scatterers that are well outside the acoustic beam to return echoes that will be interpreted as objects within the beam. Figure 14 shows an example with a cylindrical rod placed at 25° on the left side of the image and a foam scatterer placed just to the right of the center line. A mirror image of the foam can be seen because of pulses that reflect off the rod, scatter off the foam, and reflect off the rod again back to the probe. The time delay of the returning echo is interpreted to produce an image in which the second surface is reflected about the tangent plane of the first surface.

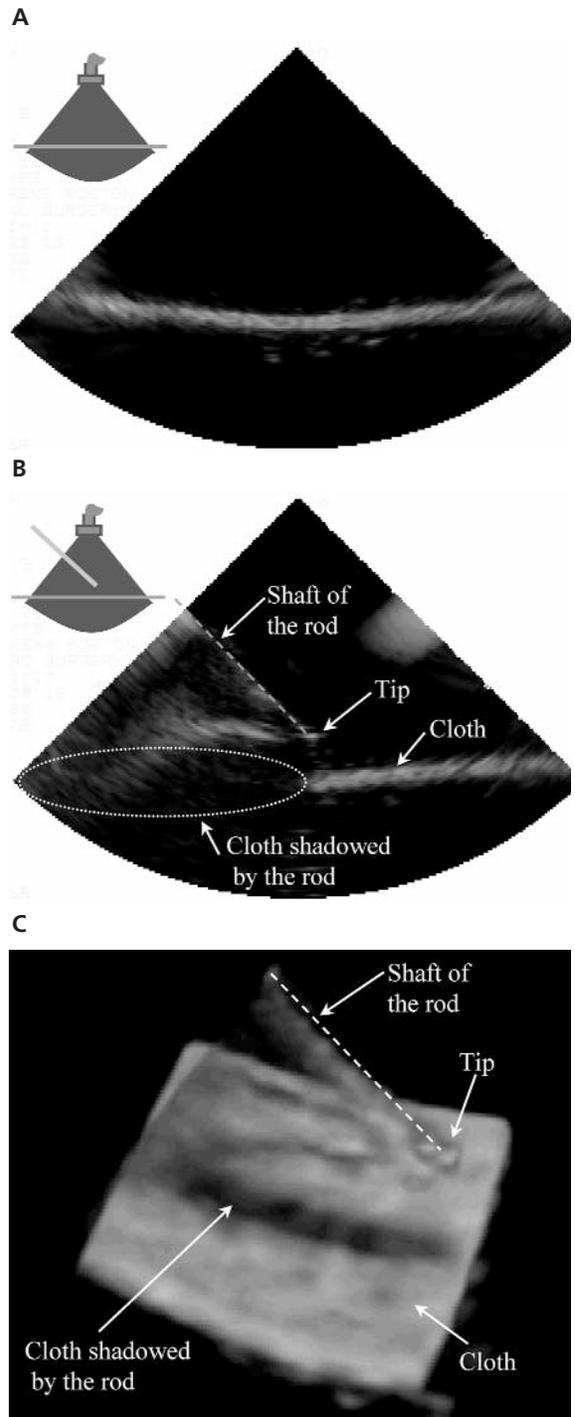
Figure 15. Shadowing from a stainless steel rod on a cloth surface. **A**, 2D image of the cloth alone. **B**, 2D image of a stainless steel rod on top of the cloth. **C**, 3D image of a stainless steel rod on top of the cloth.

Shadowing—When imaged with tissue or other objects, metal instruments, like bone, create shadow regions in ultrasound images. These arise because those sound waves that are transmitted through the front and back surfaces of an instrument are not of sufficient intensity to reflect off tissue and pass back through the instrument to reach the probe. Figure 15 shows a pronounced shadow created by a stainless steel rod on a planar cloth surface.

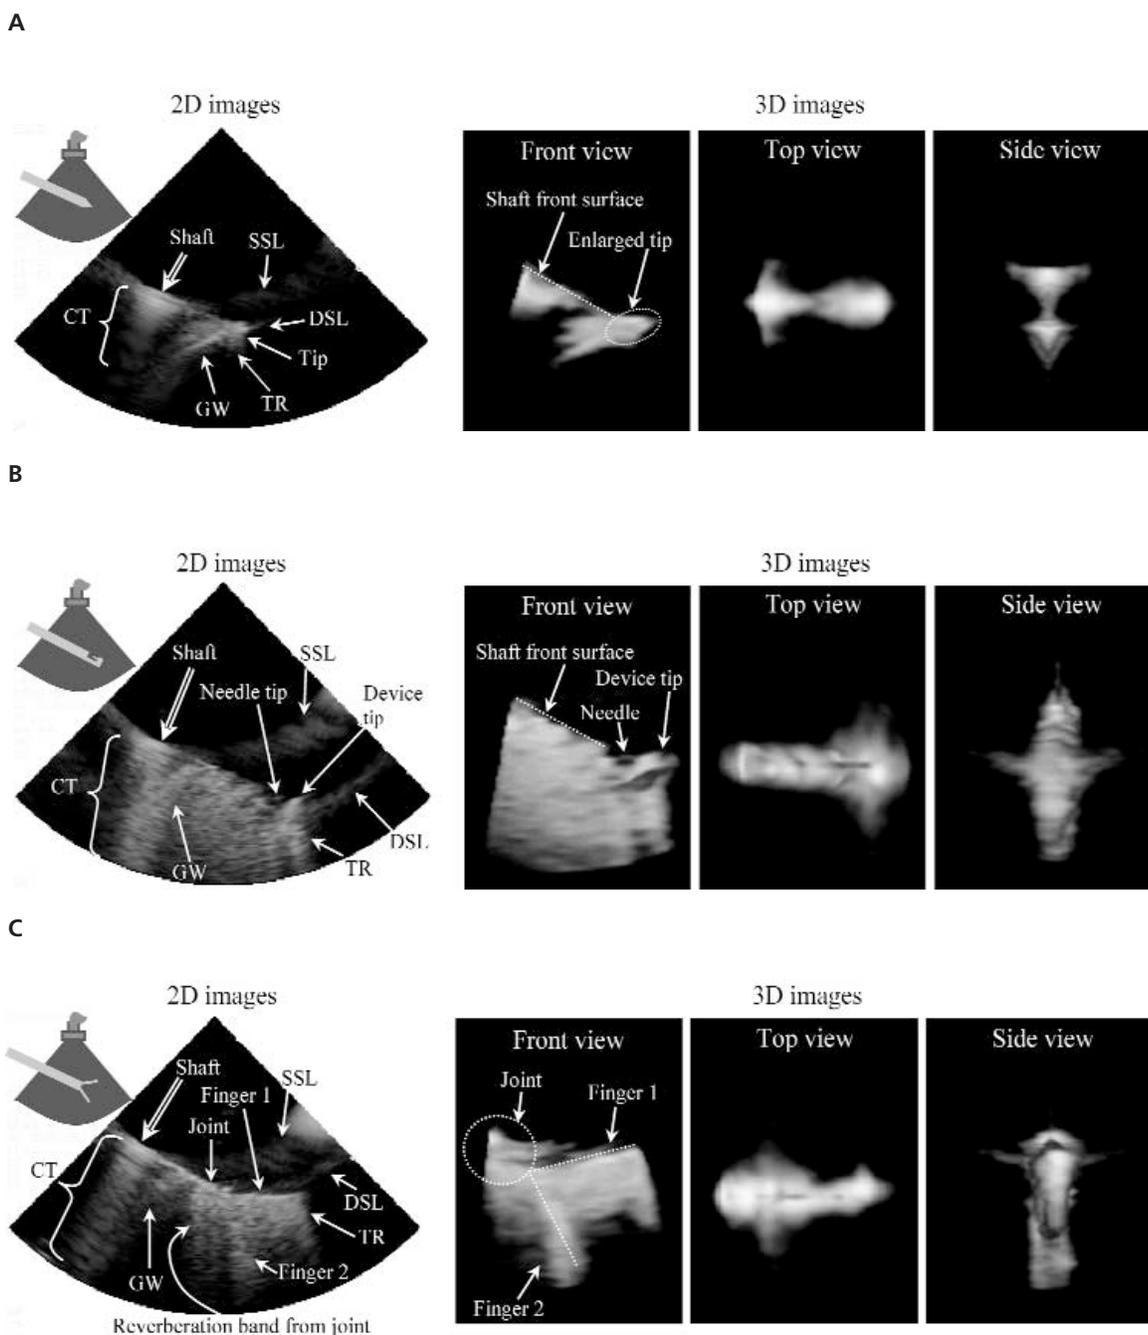
Figure 16. Clinical instrument images in water. **A**, 19-gauge needle. **B**, Suturing device with a needle. **C**, Forceps. Labeled artifacts: CT, comet tail; DSL, diffractive side lobe; GW, guided wave; SSL, specular side lobe; and TR, tip reverberation.

Figure 16 shows both 2D and 3D water tank images of the 19-gauge needle, suturing device, and forceps displayed in Figure 3. The artifacts observed with rods can be seen in these images. The images of the 19-gauge needle (Figure 16A and Video 1) include a comet tail artifact, 3 guided wave artifacts, a tip reverberation artifact, a diffractive side lobe artifact, and a specular side lobe artifact.

The suturing device (Figure 16B and Video 2) produced comet tail, guided wave, specular side lobe, diffractive side lobe, and tip reverberation artifacts. For this device, the reverberation artifacts are not as distinct as those of the needle.

This is likely due to the main shaft's being constructed from 2 semicylinders that introduce an extra boundary for reflections. In addition, bubbles can be trapped between the 2 semicylinders and produce a ring-down artifact. In the vicinity of the slot (where the needle is), the artifacts make visualizing the needle and slot almost impossible.

The forceps (Figure 16C and Video 3) also produced comet tail, guided wave, and specular side lobe artifacts, although, as with the suturing device, they were not as clear as the needle. The forceps produces a reverberation band behind the joint (where the fingers connect to the shaft), which may be due to a comet tail artifact or could be due to ring-down associated with air bubbles in the joint. The 2 fingers of the forceps are tapered semicylinders with ridged grasping surfaces. The ridges form a rough surface, which may reduce the patterned reverberation bands in the finger while diffracting sound to the neighboring edges, which may produce echoes back to the transducer. The result is a cloud underneath the front smooth surface of the finger (Figure 16C, finger 1), and the tip of the finger does not produce a strong artifact.

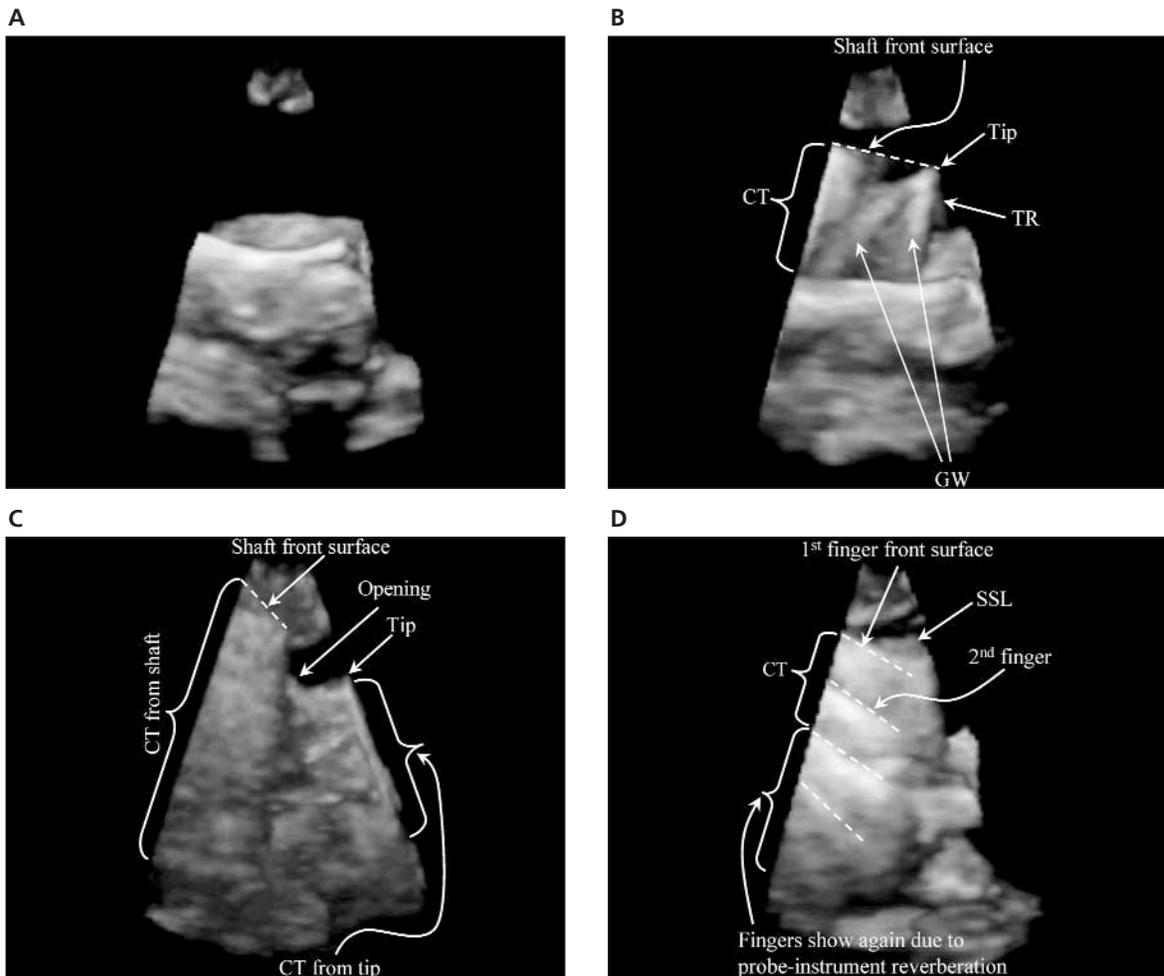
Figure 17. Three-dimensional images of instruments in the right atrium of a beating porcine heart. **A**, Tissue image without an instrument inserted. **B**, 19-gauge needle. **C**, Suturing device. **D**, Forceps. Artifact identifiers: CT, comet tail; GW, guided wave; SSL, specular side lobe; and TR, tip reverberation.

These images are of isolated instruments in a water tank, which is a near ideal imaging environment. In vivo conditions are much less ideal, as shown by the images in Figure 17 and Videos 4–7, depicting these tools in the right atrium of a beating pig heart. As shown, the combination of reflections from an instrument and tissue

produces images that are very hard to decipher. For example, the guided wave artifacts from the tip of the needle (Figure 17B) resemble the for-

ceps' fingers. Reverberation artifacts from the suturing device (Figure 17C) completely obscure the tissue. The forceps itself also obscures the tissue and produces ghost images due to reverberation between the instrument and the probe.

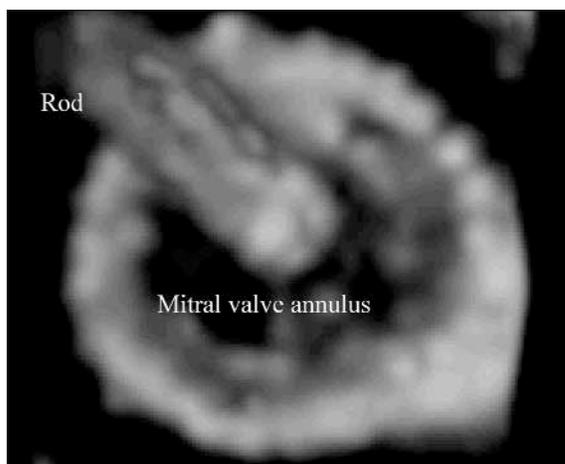
Figure 18. Image of a rod positioned in the center of a porcine in vitro pulsatile mitral valve model, as described in Figure 1, where the image-rendering viewpoint was selected to place artifacts in the instrument shadow.

One such technique that can be used even when the probe and instruments must be positioned close to each other is to place artifacts in the shadow of an instrument. In the absence of artifacts, these shadows appear as dark silhouettes on tissue located on the far side of an instrument from the probe. All the reverberation artifacts described in the article as well as mirror image artifacts lie in the shadow region of the instrument. Given their location, they cannot represent any real object, instrument or tissue, and so can be ignored.

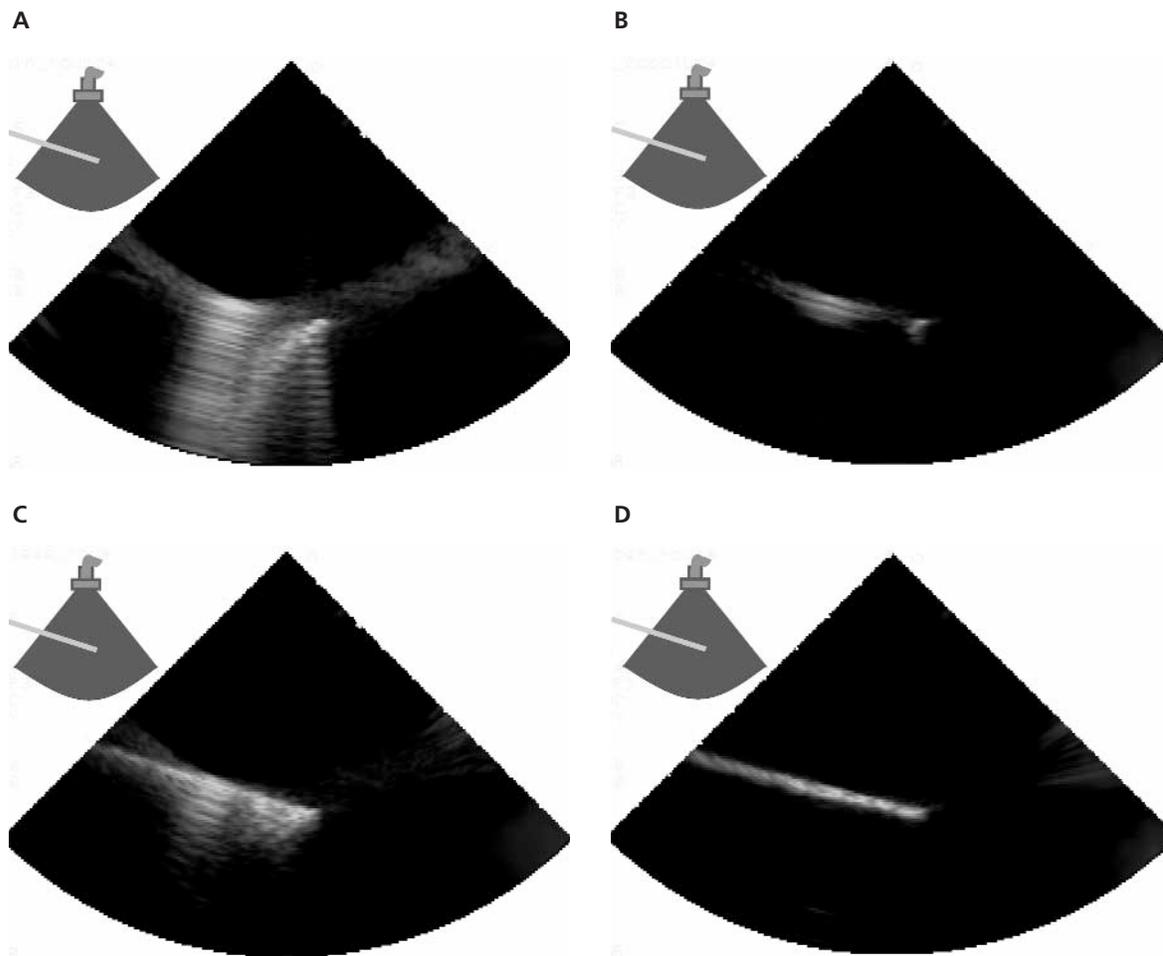
Figure 19. Effect of material on imaging for a 3.2-mm-diameter rod in water with its axis at 15° from horizontal. **A**, Stainless steel. **B**, Acetyl copolymer. **C**, Fiberglass. **D**, Vulcanized Franklin fiber processed from cotton.

Modification techniques that reduce the intensity and specularity of instrument echoes can improve the image produced by the initial echo from the central beam lobe as well as reduce or eliminate artifacts arising from multiple reflections and side lobe echoes. The most drastic approach to modification is to redesign instruments using materials other than metal. Simpler modifications to existing instruments involve changing the surface finish or adding a coating to the surface. Several examples of alternate materials are presented in Figure 19. Materials with an acoustic impedance closer to that of tissue will produce fewer and less intense artifacts than metals such as stainless steel. The copolymer and fiberglass rods, for example, show comet tail and tip artifacts similar to those of steel, but the extent of the artifact is dramatically less than that of steel. If a material is also a diffusive reflector, such as the Franklin fiber (Figure 19D), it will be highly visible as well.

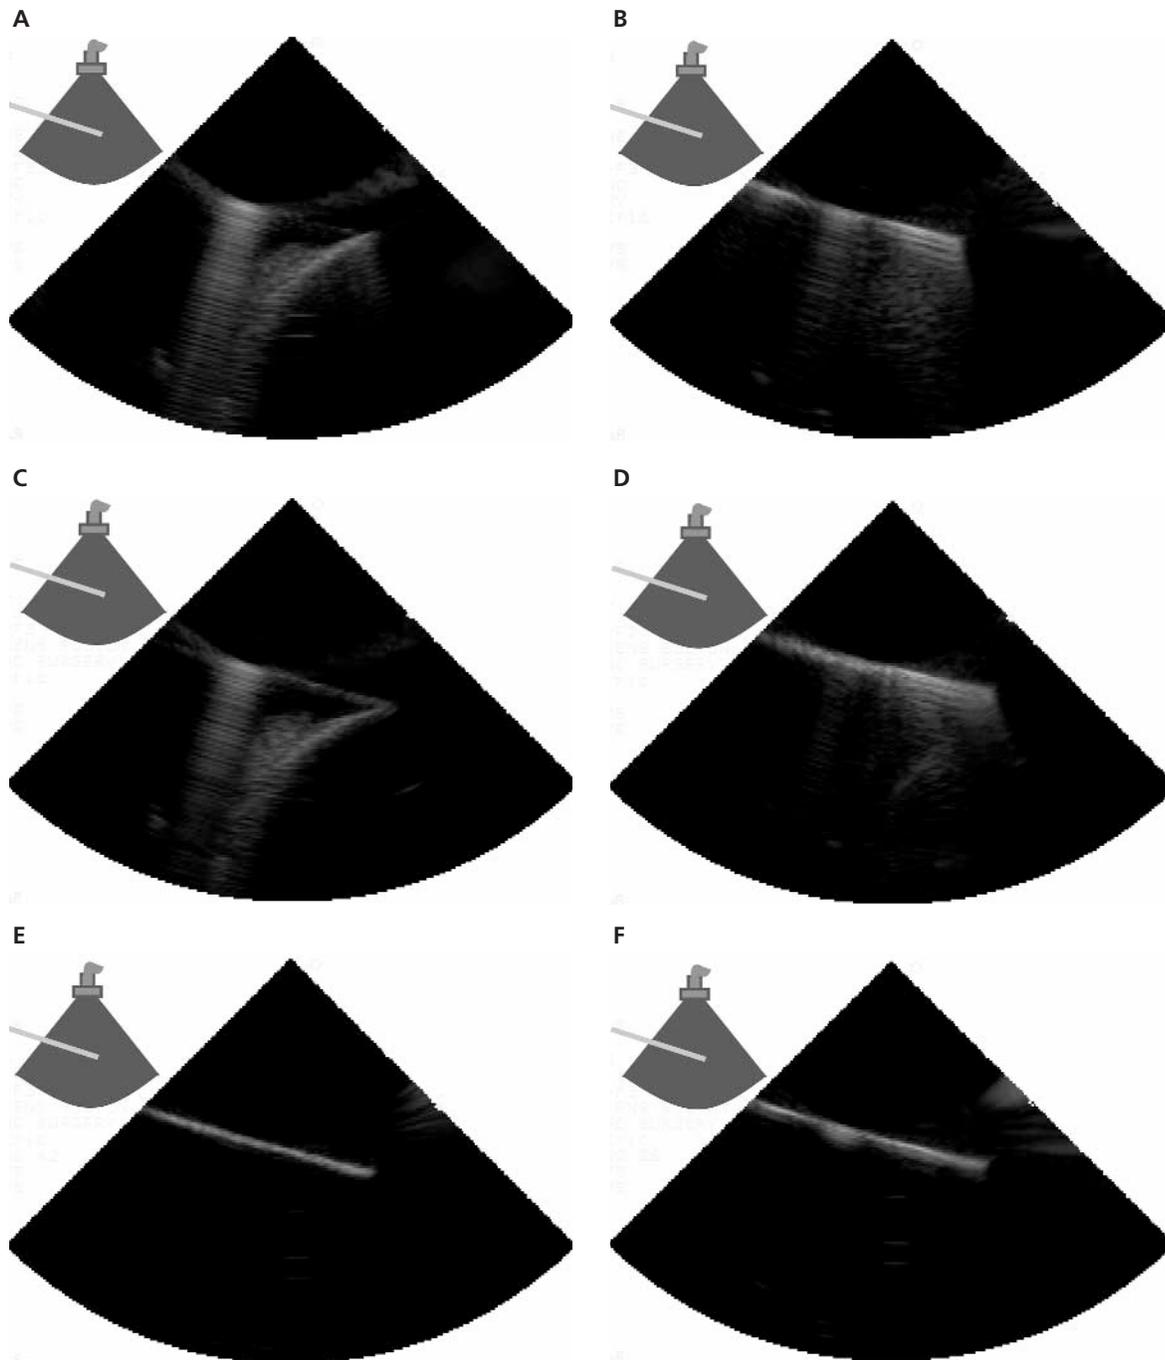
Figure 20. Effect of surface treatment on imaging for a 3.2-mm-diameter stainless steel rod in water with its axis at 15° from horizontal. **A**, Smooth surface. **B**, Threaded surface. **C**, Smooth surface coated with Teflon (0.03 mm thick). **D**, Threaded surface coated with Teflon (0.09 mm thick). **E**, Smooth surface coated with polyurethane foam (0.8 mm thick). **F**, Threaded surface coated with polyvinylidene difluoride (0.14 mm thick).

Modifying the surfaces of existing metal instruments, either through surface finish or by adding a coating, can also lead to a substantial reduction of artifacts, as shown in Figure 20 and Videos 8–11. A roughened surface (Figure 20B) was able to reduce reverberation artifacts of a stainless steel instrument to those seen with the copolymer or fiberglass rods. The rough surface distorts the wave front entering and leaving the instru-

An absorptive coating can be added to a rough surface to further reduce the side lobe artifacts and residual reverberation (Figure 20, D and F). Alternatively, a coating that is both diffusive and absorptive will both enhance visibility and reduce artifacts; for example, polyurethane foam on a smooth steel surface (Figure 20E) results in

an excellent image of the rod. An additional advantage of this approach is that coating the surface of an existing instrument is typically simpler and less expensive than mechanically roughening its surface. As an example, images of

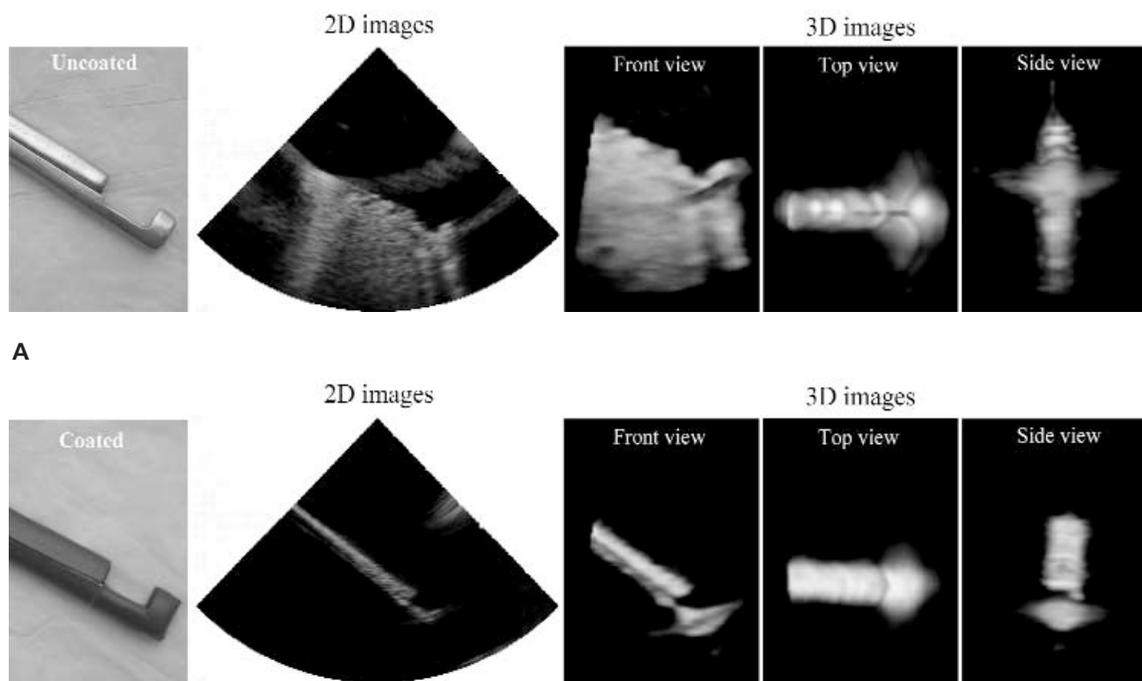
Figure 21. Effect of polyurethane foam coating on suturing device imaging. **A**, Uncoated. **B**, Coated with polyurethane foam.

a suturing device coated with polyurethane foam are shown in Figure 21 and Video 12. The images of the coated device result in a faithful reproduction of the instrument, and the large reverberation artifacts of Figure 16B are absent. The notch

is clearly visible, and the curvilinear artifacts that emanated from the tip of the untreated instrument are dramatically reduced.
